Re: Principal Threat Wastes Technical Memorandum
Sauget Area 2
Sauget, Illinois

Subject: **Principal Threat Wastes Technical Memorandum-Revised**

This technical memorandum summarizes existing data regarding the presence of non-aqueous phase liquid (NAPL) and buried drums at Sauget Area 2 (SA2) and provides an evaluation of whether the NAPL or buried drums containing liquid waste materials would constitute principal threat wastes.

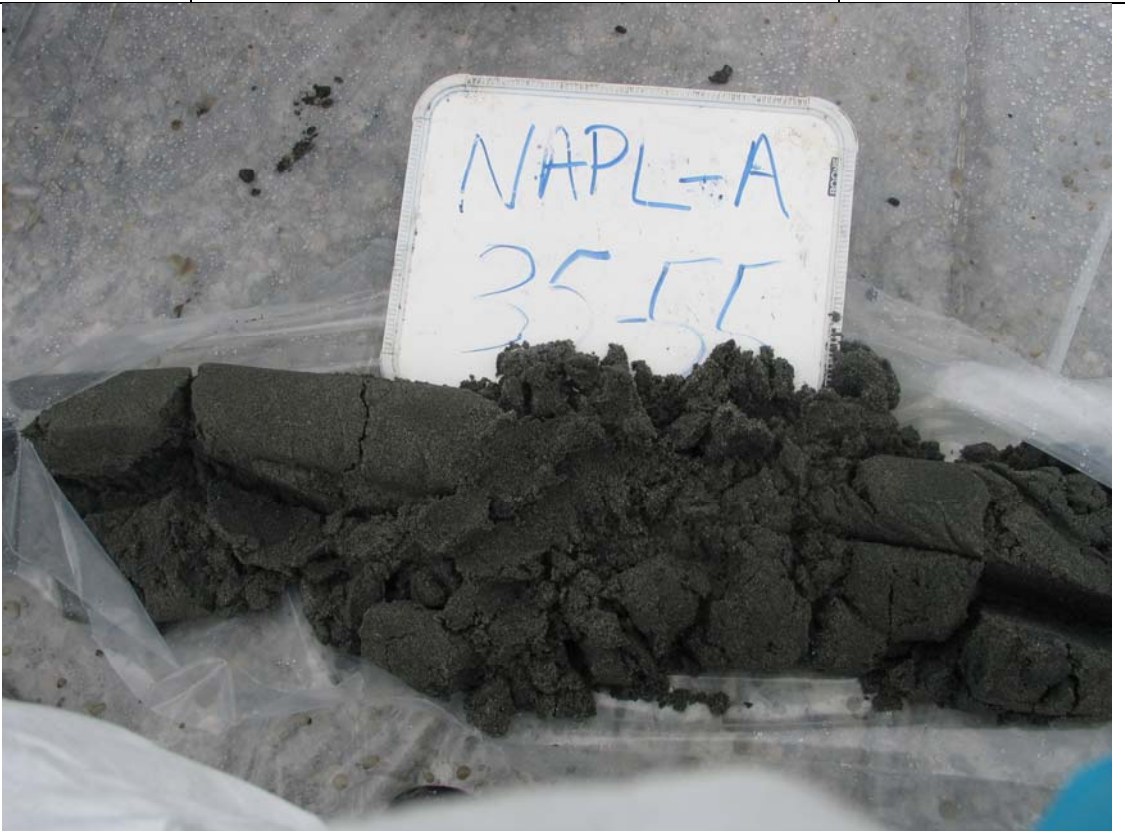
Client Name: Sauget Area 2 Sites Group		Site Location: Sauget, Illinois	Project No. 21561683
Photo No. 7	Date: 5/10/06

A photograph showing a dark, clumpy soil sample in a clear plastic bag. A white label with blue handwritten text "NAPL-A" and "35-55'" is placed on top of the soil. The background is a light-colored, textured surface.	
Description: NAPL-A (35-55')

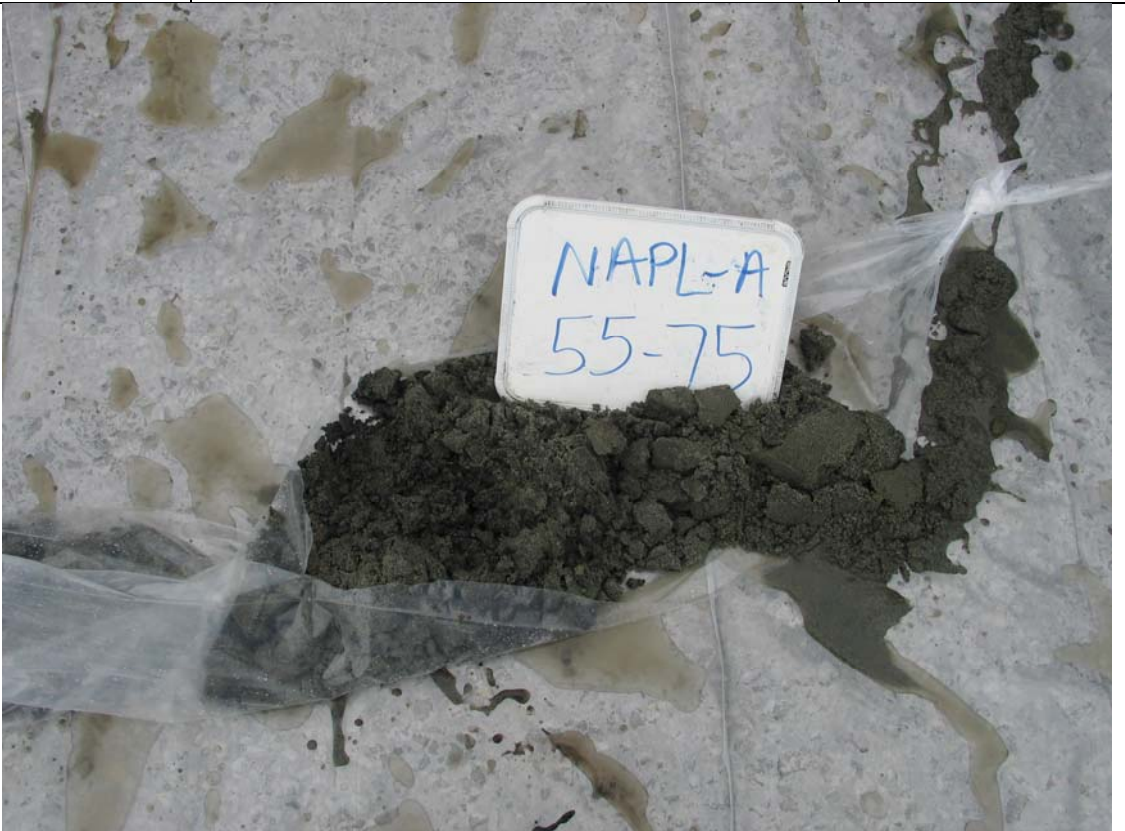
Client Name: Sauget Area 2 Sites Group		Site Location: Sauget, Illinois	Project No. 21561683
Photo No. 9	Date: 5/10/06

A photograph of a dark, granular soil sample placed on a light-colored, possibly plastic, surface. A small white label with blue handwritten text "NAPL-A" and "55-75" is positioned on top of the soil. There are some brownish stains on the surface around the sample.	
Description: NAPL-A (55-75')

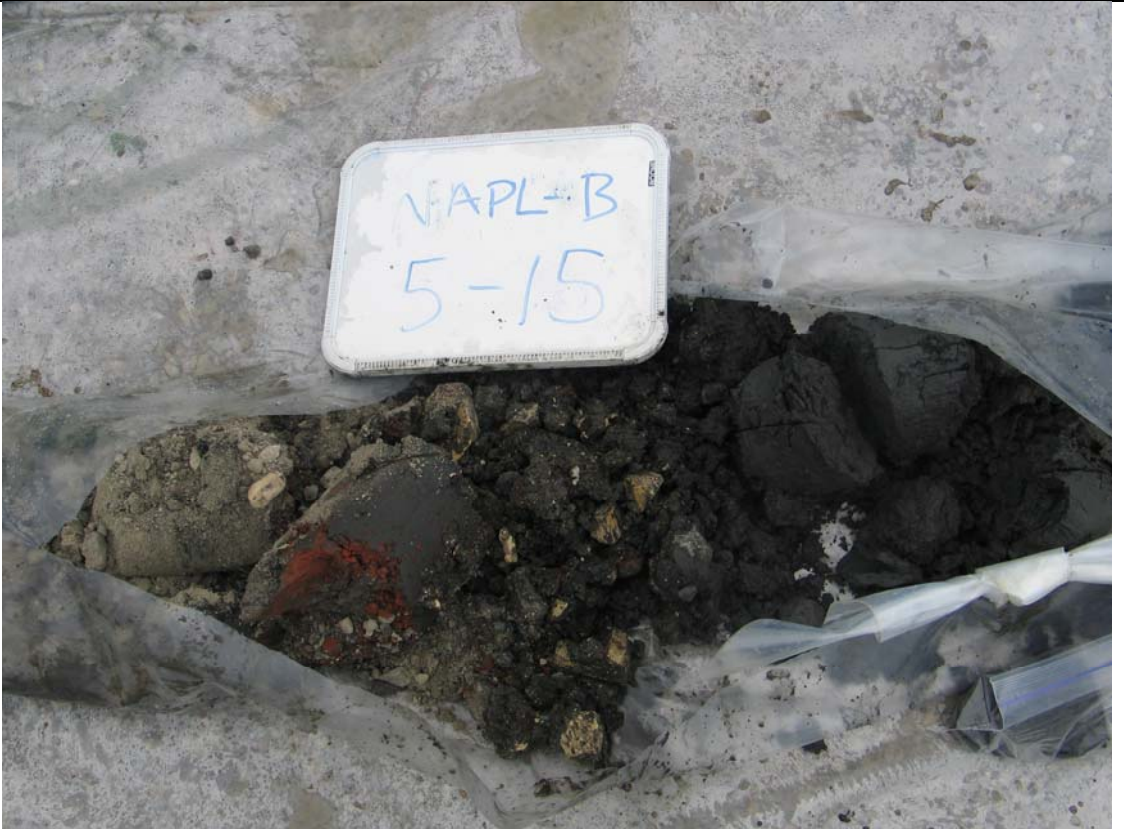
Client Name: Sauget Area 2 Sites Group		Site Location: Sauget, Illinois	Project No. 21561683
Photo No. 3	Date: 5/9/06

A photograph showing a dark, granular soil sample in a clear plastic bag. A white label with blue handwritten text "NAPL-B" and "5-15" is placed on top of the sample. The sample is resting on a light-colored, textured surface.	
Description: NAPL-B (5-15')

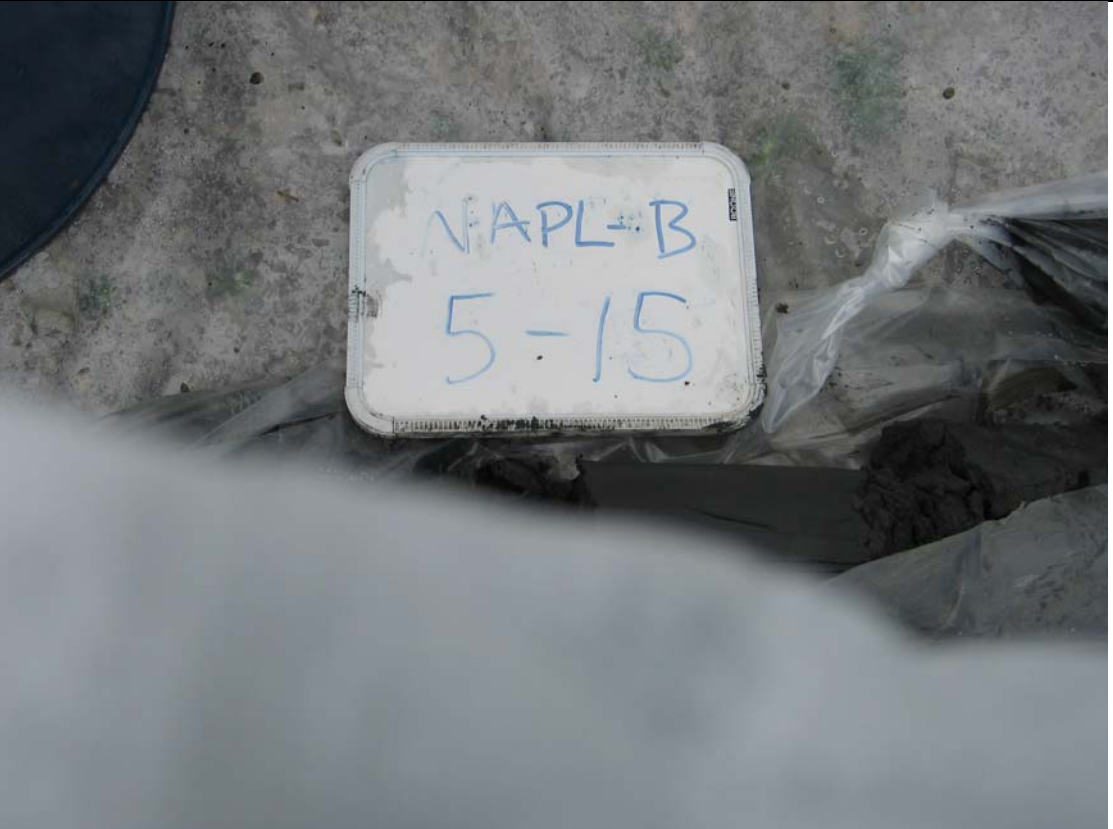
Client Name: Sauget Area 2 Sites Group		Site Location: Sauget, Illinois	Project No. 21561683
Photo No. 5	Date: 5/9/06

A photograph showing a white, rectangular container with a metal rim. The container is placed on a dark, possibly black, plastic liner. The container has "NAPL-B" and "5-15" written on it in blue marker. The background is a light-colored, textured surface, possibly concrete or gravel.	
Description: NAPL-B (5-15')

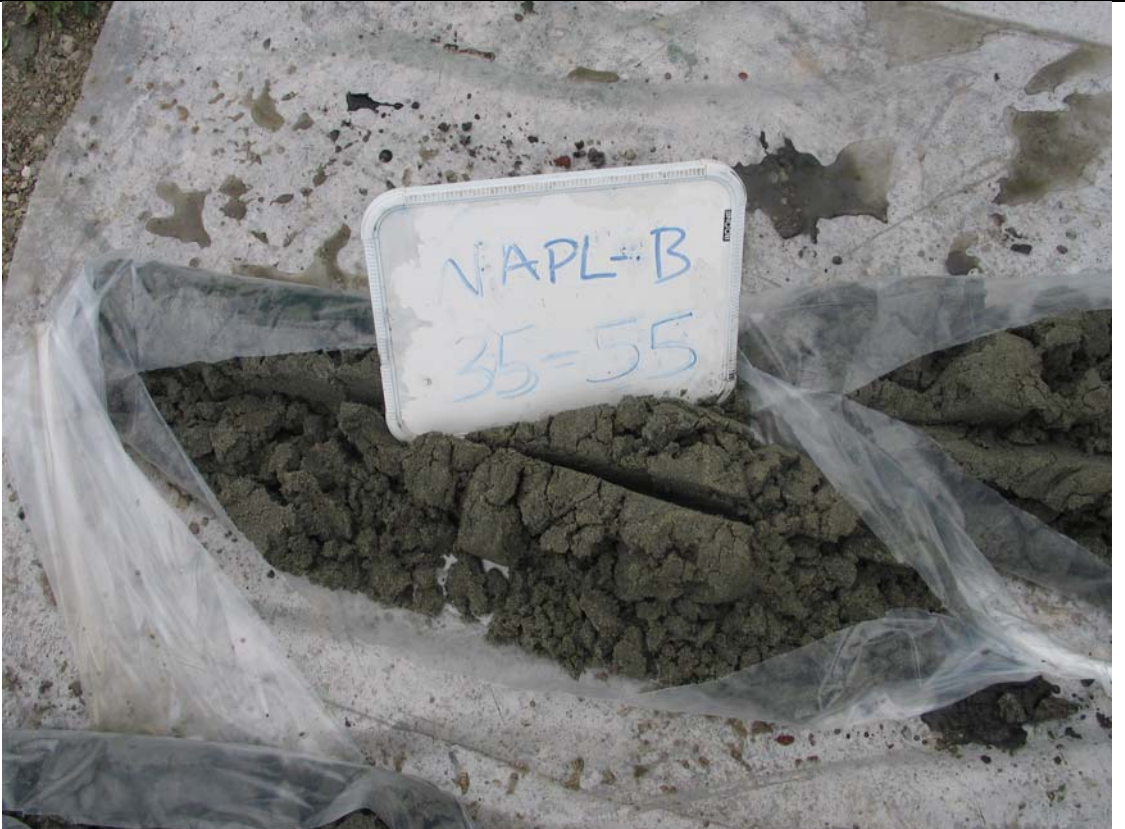
Client Name: Sauget Area 2 Sites Group		Site Location: Sauget, Illinois	Project No. 21561683
Photo No. 9	Date: 5/9/06

A photograph showing a dark, clumpy soil sample contained within a clear plastic bag. A white rectangular label with blue handwritten text "NAPL-B" and "35-55" is placed on top of the soil. The background is a light-colored, possibly concrete, surface.	
Description: NAPL-B (35-55')

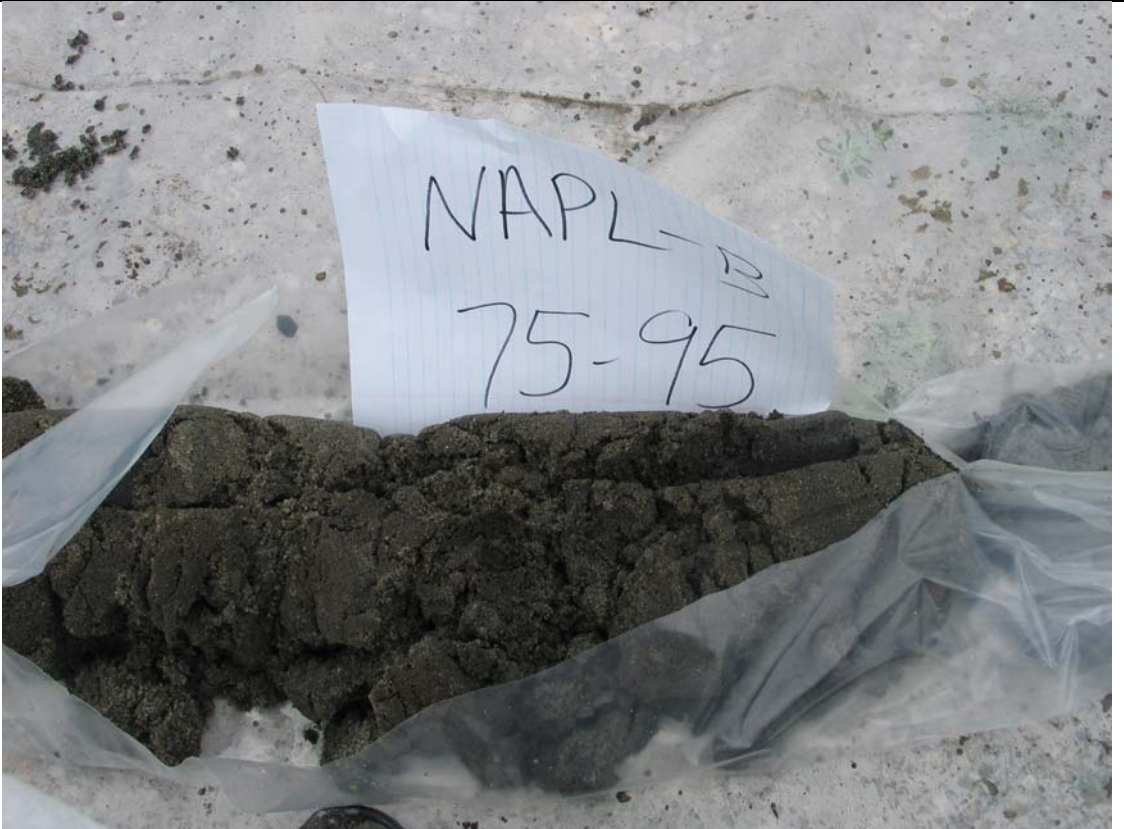
Client Name: Sauget Area 2 Sites Group		Site Location: Sauget, Illinois	Project No. 21561683
Photo No. 13	Date: 5/9/06

A photograph showing a dark, clumpy soil sample placed on a light-colored concrete surface. A white piece of paper with the handwritten text "NAPL-B" and "75-95" is positioned behind the soil. The soil is partially enclosed by a clear plastic bag.	
Description: NAPL-B (75-95')

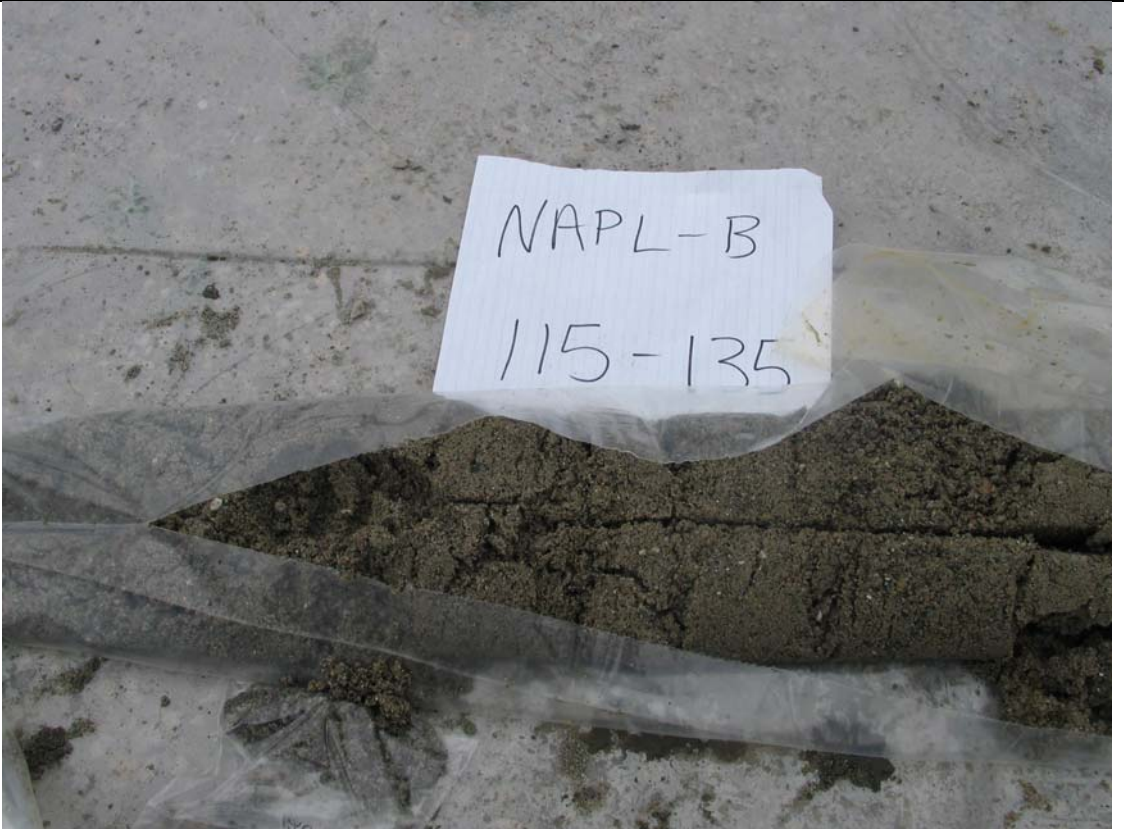
Client Name: Sauget Area 2 Sites Group		Site Location: Sauget, Illinois	Project No. 21561683
Photo No. 17	Date: 5/9/06

A photograph showing a soil sample in a clear plastic bag. The soil is dark brown and appears to be a fine-grained material. A white piece of paper is placed on top of the bag with the handwritten text "NAPL-B" and "115-135". The bag is resting on a light-colored, possibly concrete, surface.	
Description: NAPL-B (115-135')

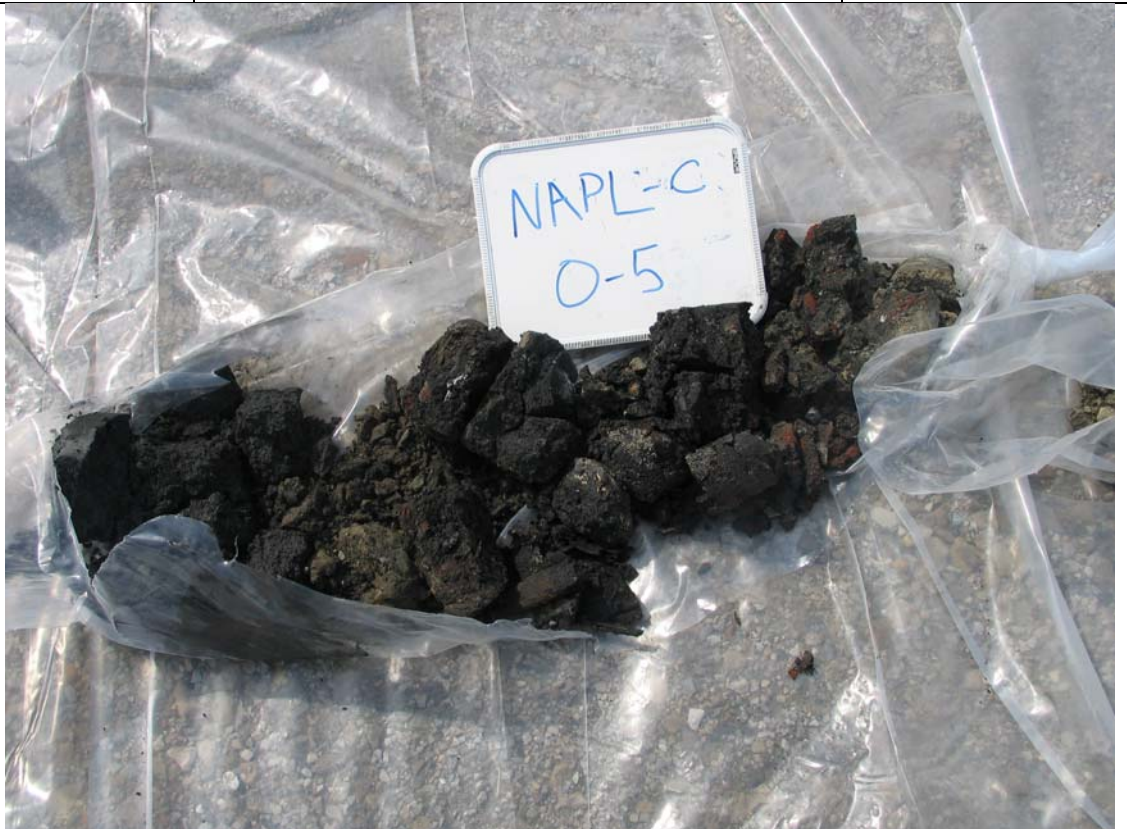
Client Name: Sauget Area 2 Sites Group		Site Location: Sauget, Illinois	Project No. 21561683
Photo No. 1	Date: 5/8/06

Description: NAPL-C (0-5')

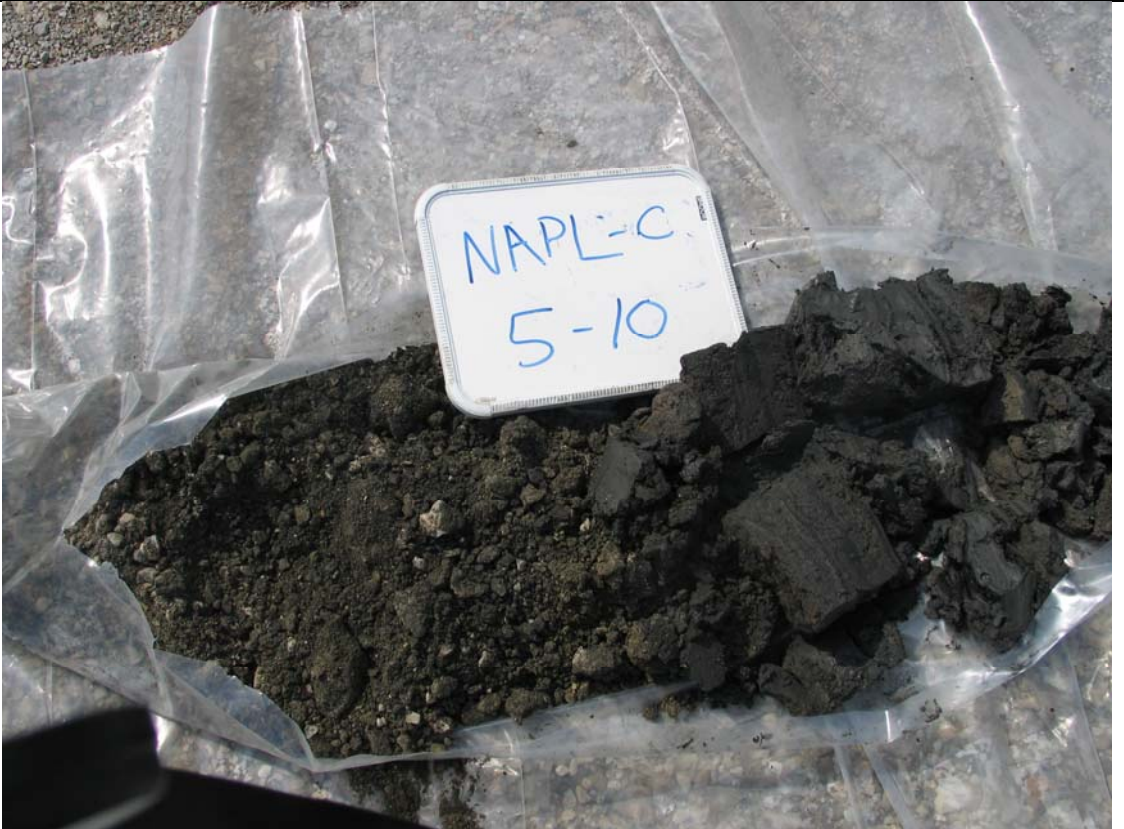
Client Name: Sauget Area 2 Sites Group		Site Location: Sauget, Illinois	Project No. 21561683
Photo No. 3	Date: 5/8/06

Description: NAPL-C (5-10')

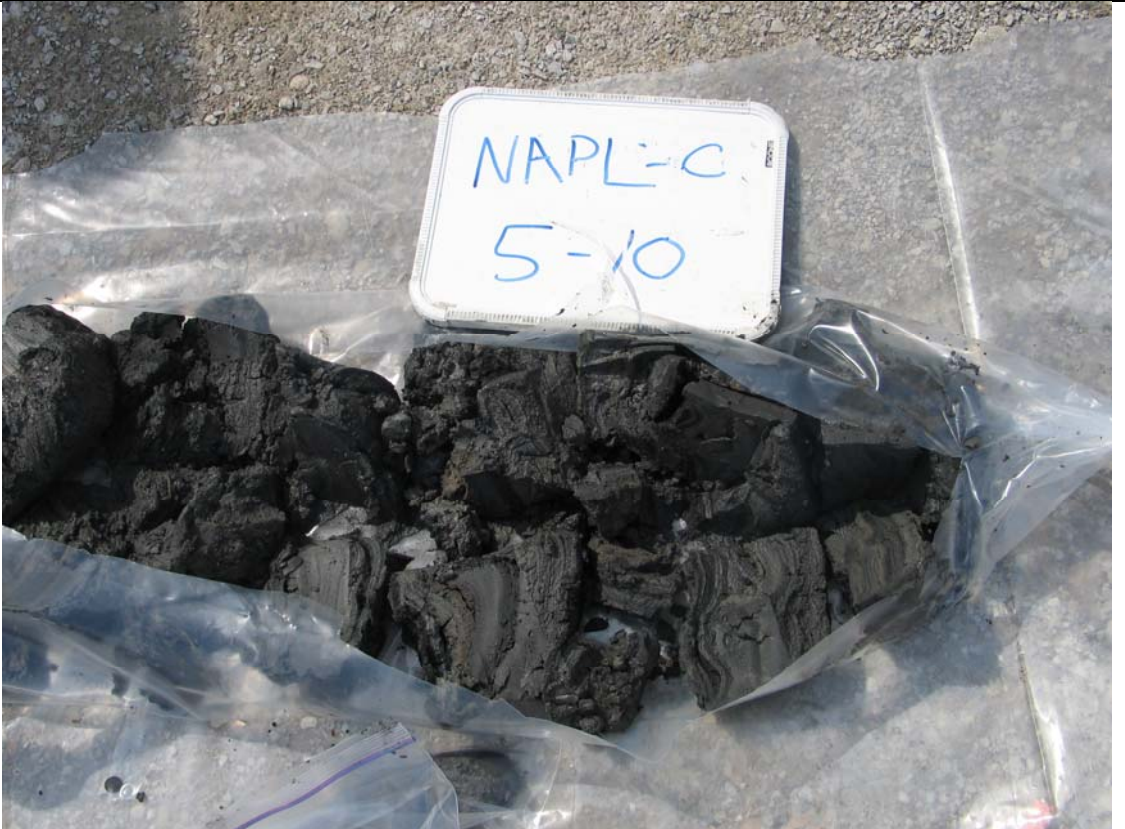
Client Name: Sauget Area 2 Sites Group		Site Location: Sauget, Illinois	Project No. 21561683
Photo No. 5	Date: 5/8/06

A photograph of a soil sample. The sample is dark, clumpy, and appears to be a mixture of soil and some organic material. It is contained within a clear plastic bag. A white label with blue handwritten text "NAPL-C" and "5-10" is placed on top of the sample. The background is a light-colored, textured surface, possibly gravel or concrete.	
Description: NAPL-C (5-10')

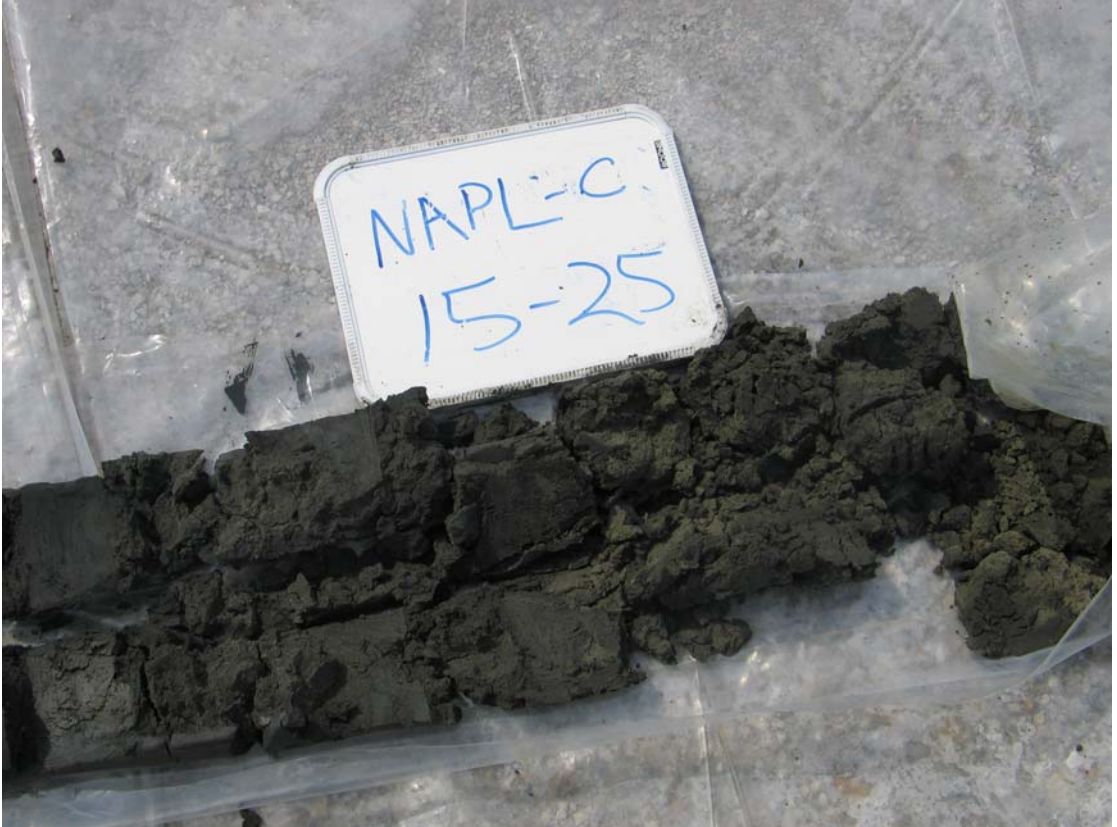
Client Name: Sauget Area 2 Sites Group		Site Location: Sauget, Illinois	Project No. 21561683
Photo No. 7	Date: 5/8/06

Description: NAPL-C (15-25')

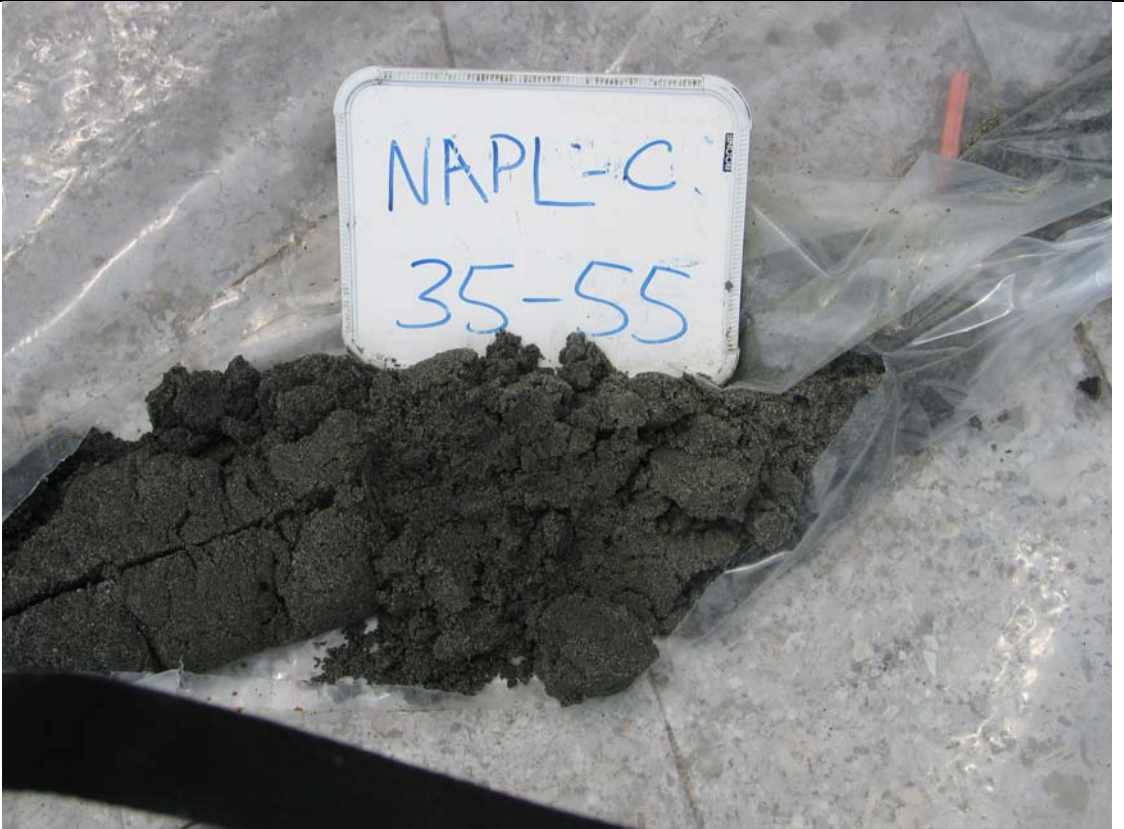
Client Name: Sauget Area 2 Sites Group		Site Location: Sauget, Illinois	Project No. 21561683
Photo No. 13	Date: 5/8/06

Description: NAPL-C (35-55')

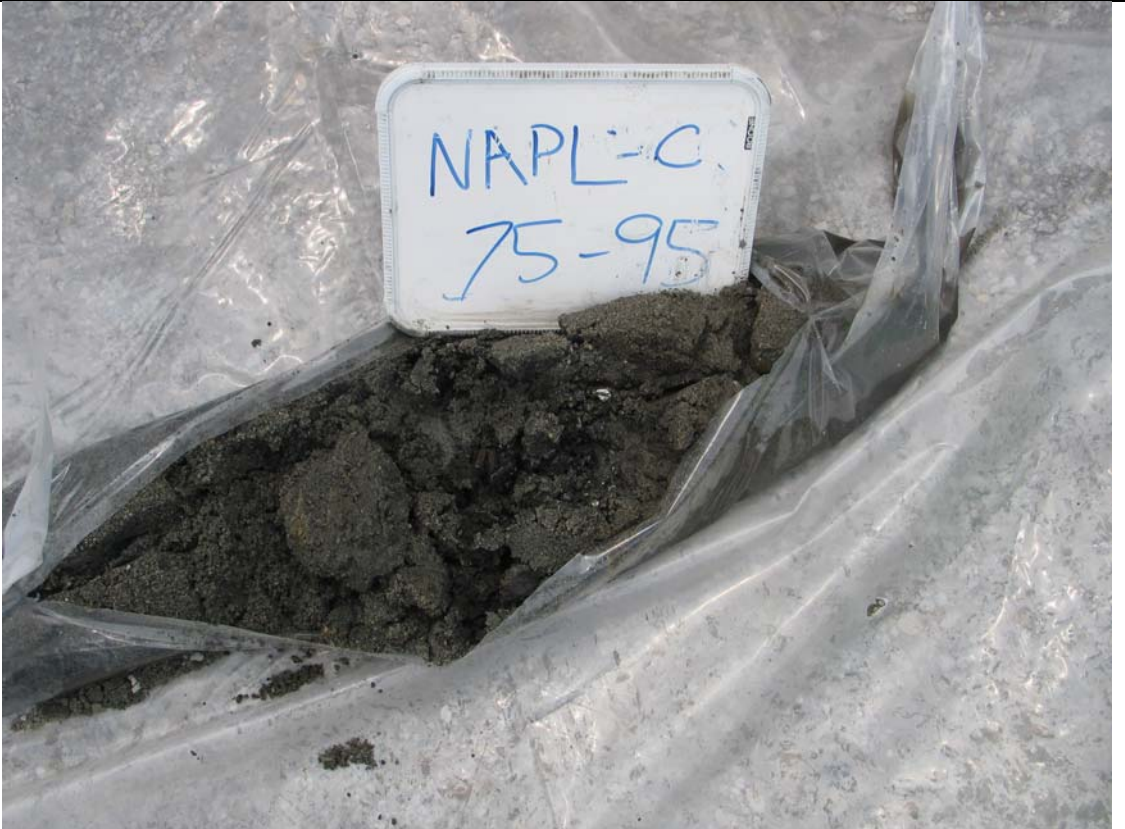
Client Name: Sauget Area 2 Sites Group		Site Location: Sauget, Illinois	Project No. 21561683
Photo No. 17	Date: 5/8/06

Description: NAPL-C (75-95')

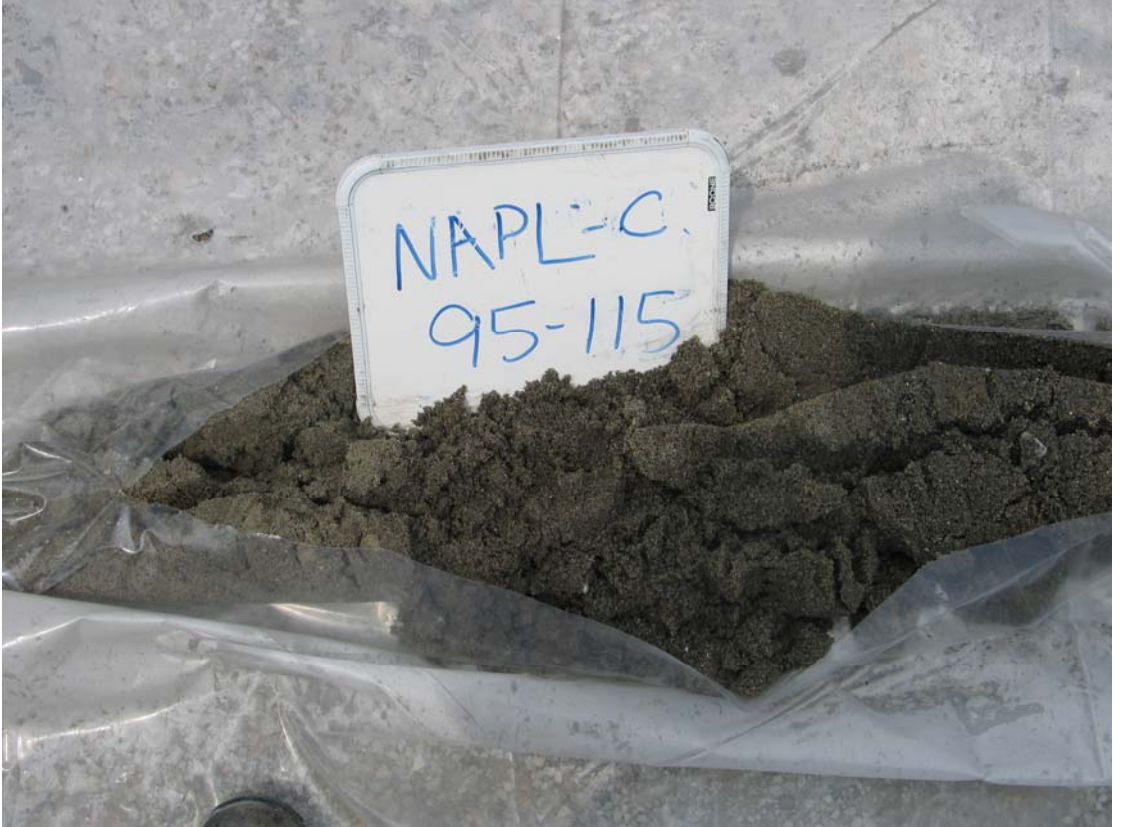
Client Name: Sauget Area 2 Sites Group		Site Location: Sauget, Illinois	Project No. 21561683
Photo No. 19	Date: 5/8/06

A photograph showing a dark, granular soil sample contained within a clear plastic bag. A white rectangular label is placed on top of the soil, with the handwritten text "NAPL-C" and "95-115" in blue ink.	
Description: NAPL-C (95-115')

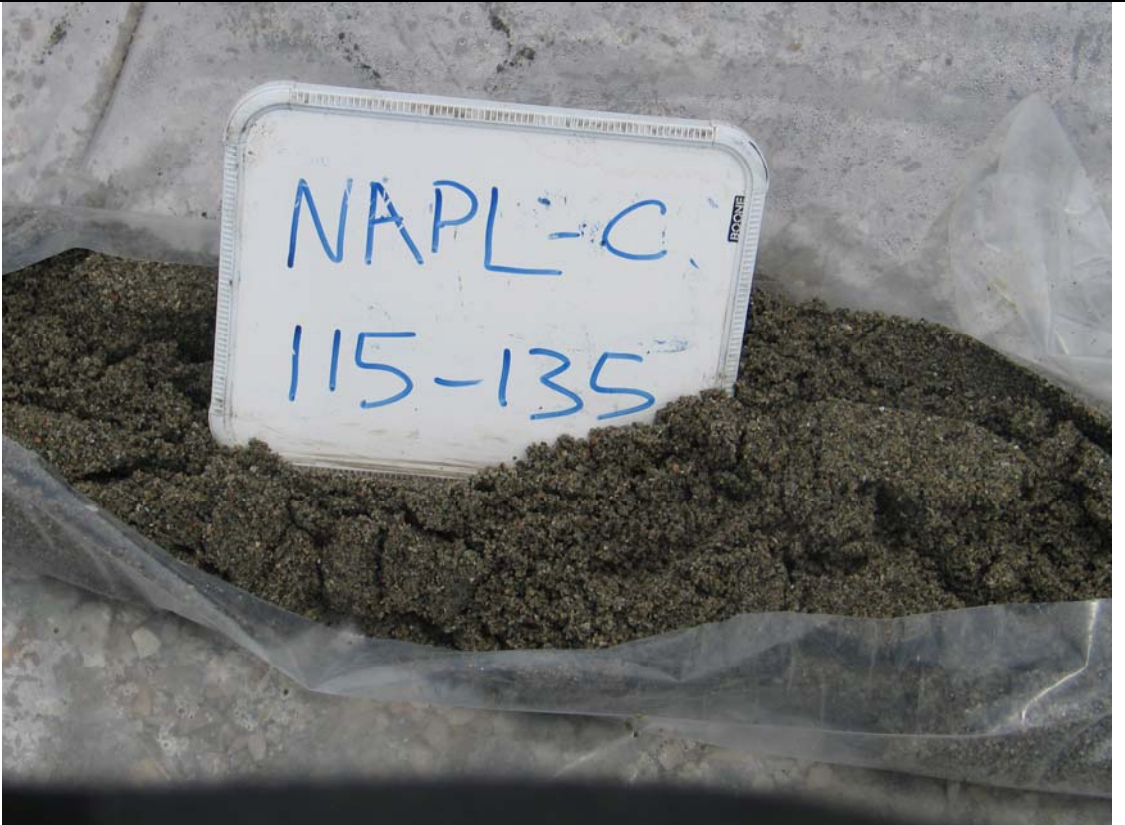
Photo No. 20	Date: 5/8/06

A photograph showing a dark, granular soil sample contained within a clear plastic bag. A white rectangular label is placed on top of the soil, with the handwritten text "NAPL-C" and "115-135" in blue ink.
Description: NAPL-C (115-135')

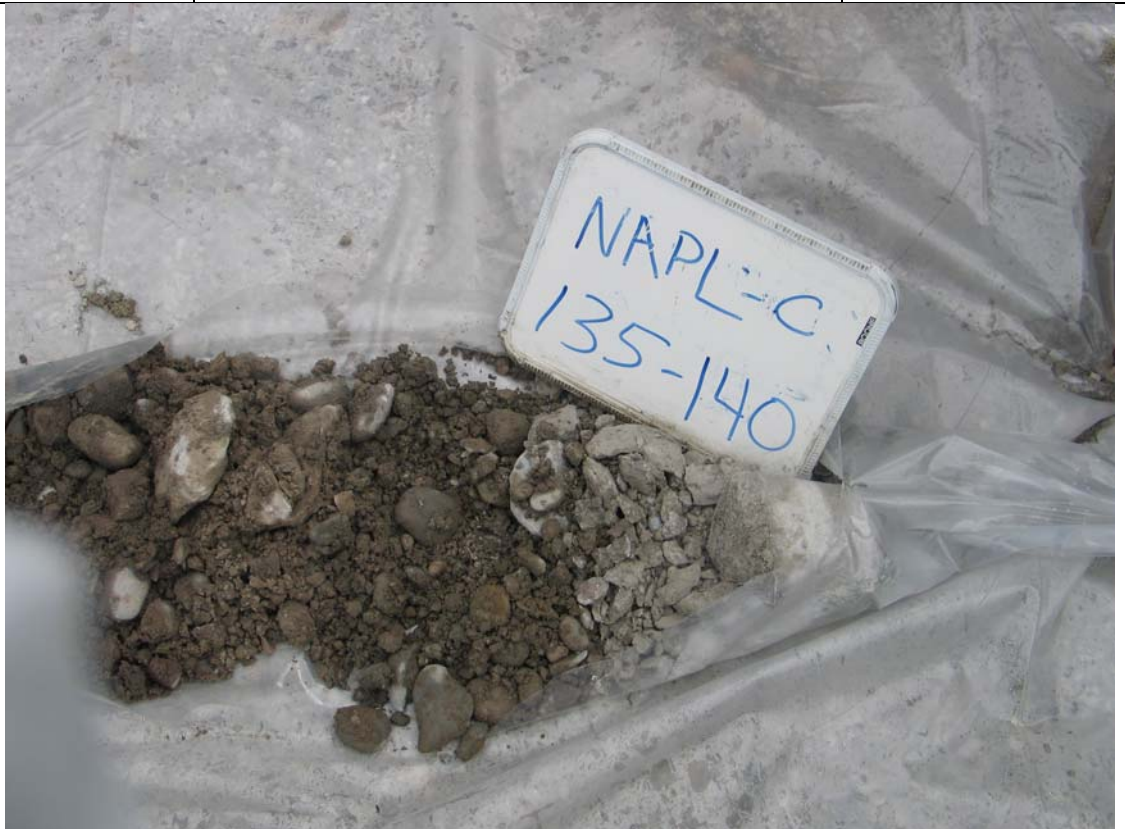
Client Name: Sauget Area 2 Sites Group		Site Location: Sauget, Illinois	Project No. 21561683
Photo No. 23	Date: 5/8/06

Description: NAPL-C (135-140')

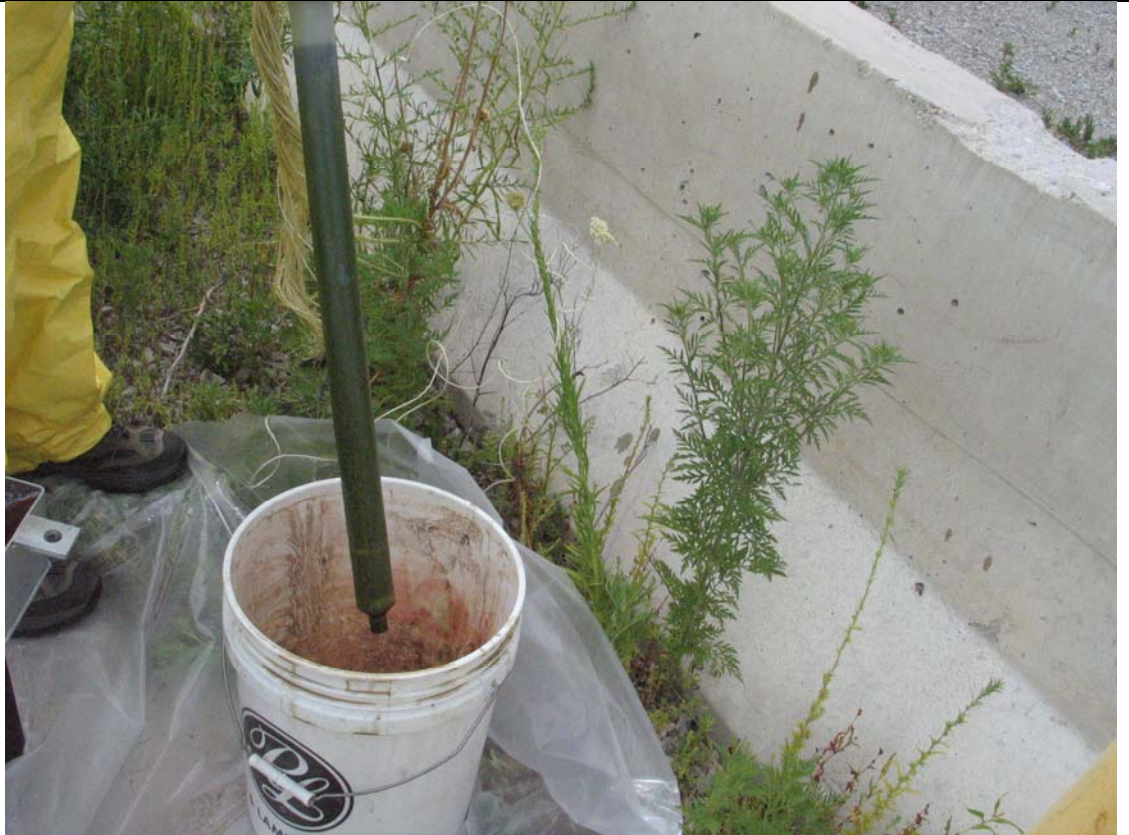
Sonic-5
Bailer coated in
D-NAPL.

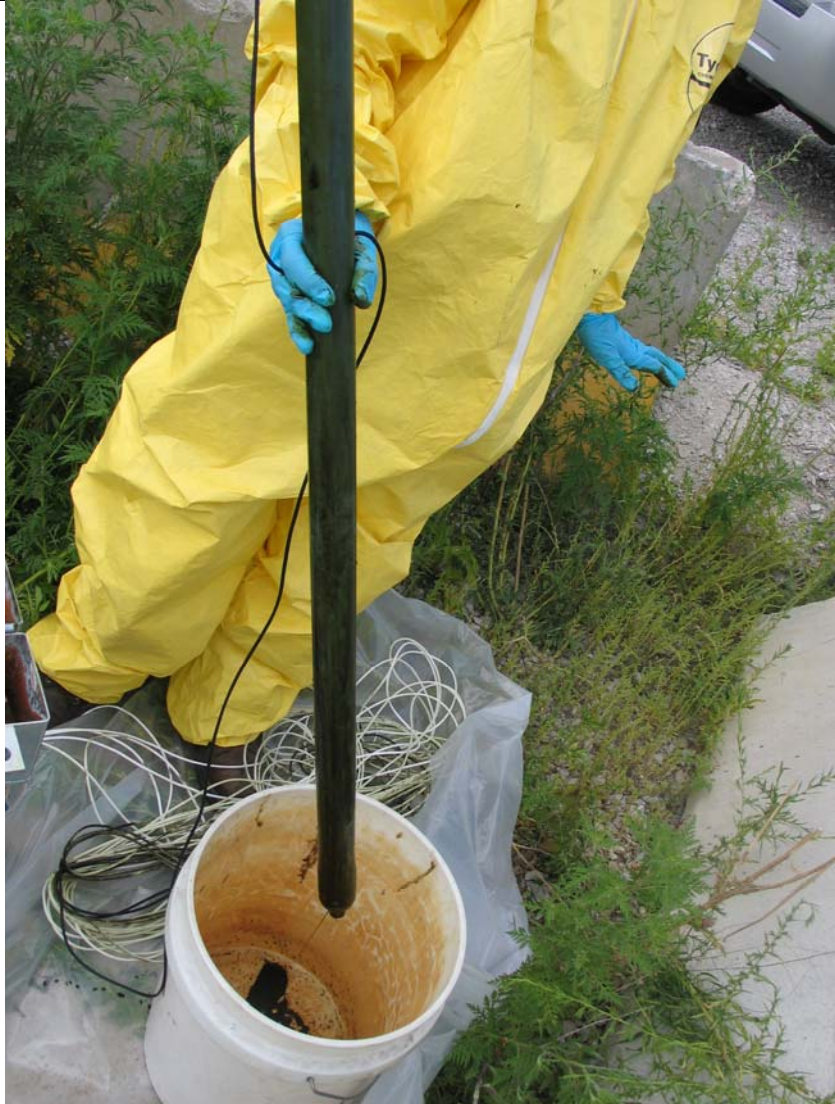
Client Name: Sauget Area 2 Sites Group		Site Location: Sauget, Illinois	Project No. 21561683
Photo No. 2	Date: 7/27/06

- SONIC-5 - During soil boring advancement and subsequent gauging, greenish-yellow colored NAPL was observed at a depth of approximately 138 to 141 feet bgs;
- LEACH-Q-1 - During the gauging event, all liquid present (~10 feet bgs) within the well at the time of gauging was NAPL;

Description: Sonic-5 Bailer coated in D-NAPL.

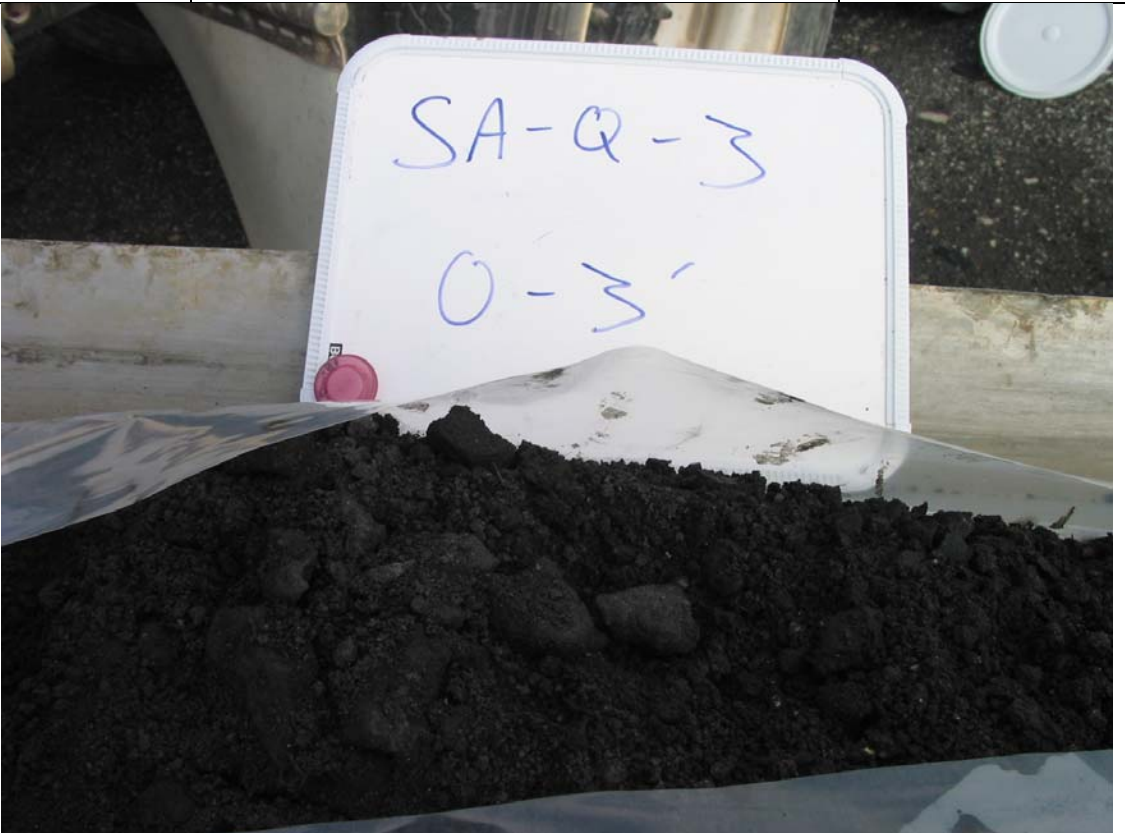
Client Name: Sauget Area 2 Sites Group		Site Location: Sauget, Illinois	Project No. 21561510
Photo No. 1	Date: 5/05/05

Description: SA-Q-3 (0-3')

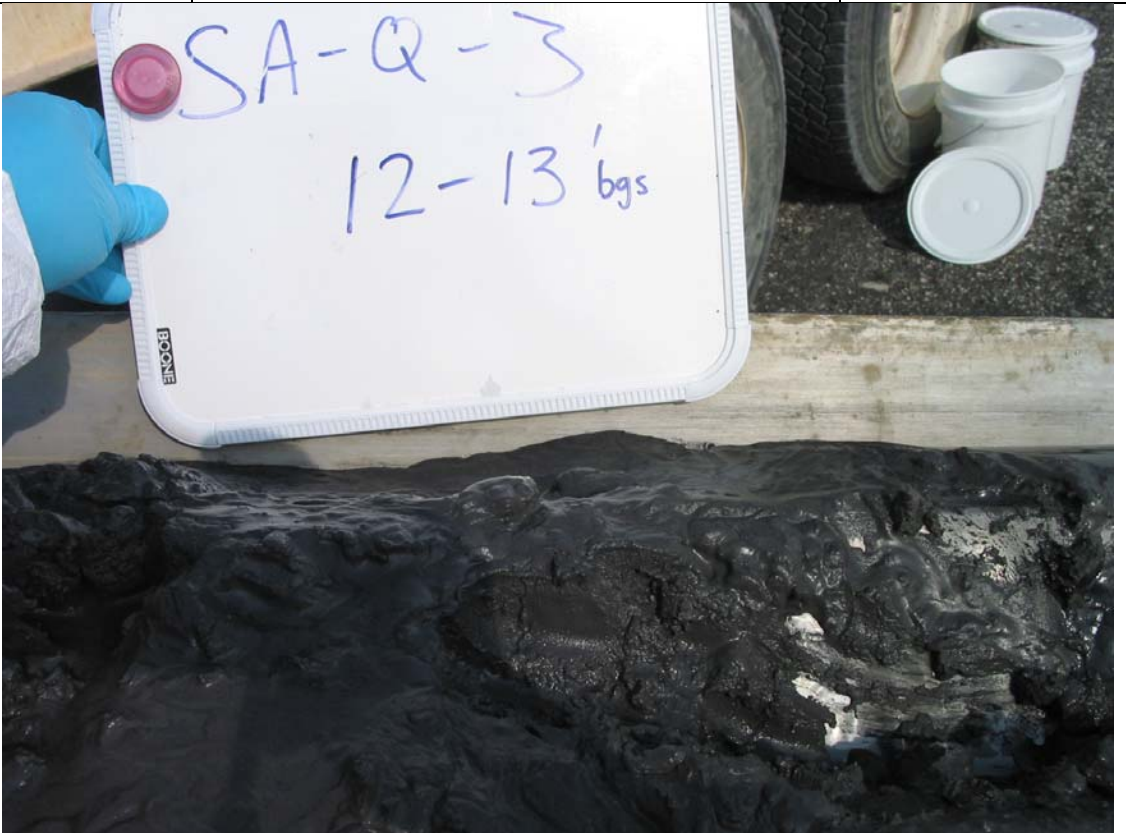
The NAPL observed within Site Q North at Sonic-5, LEACH-Q-1, PZ-6D, and PZ-8U is considered a principal threat waste; however, these locations are already controlled within the GMCS barrier wall (Operable Unit # 2.). Since NAPL was never observed in the monitoring well SA-Q-3, this location will not be considered to have principal threat waste.

Description: SA-Q-3 (12-13') NAPL present

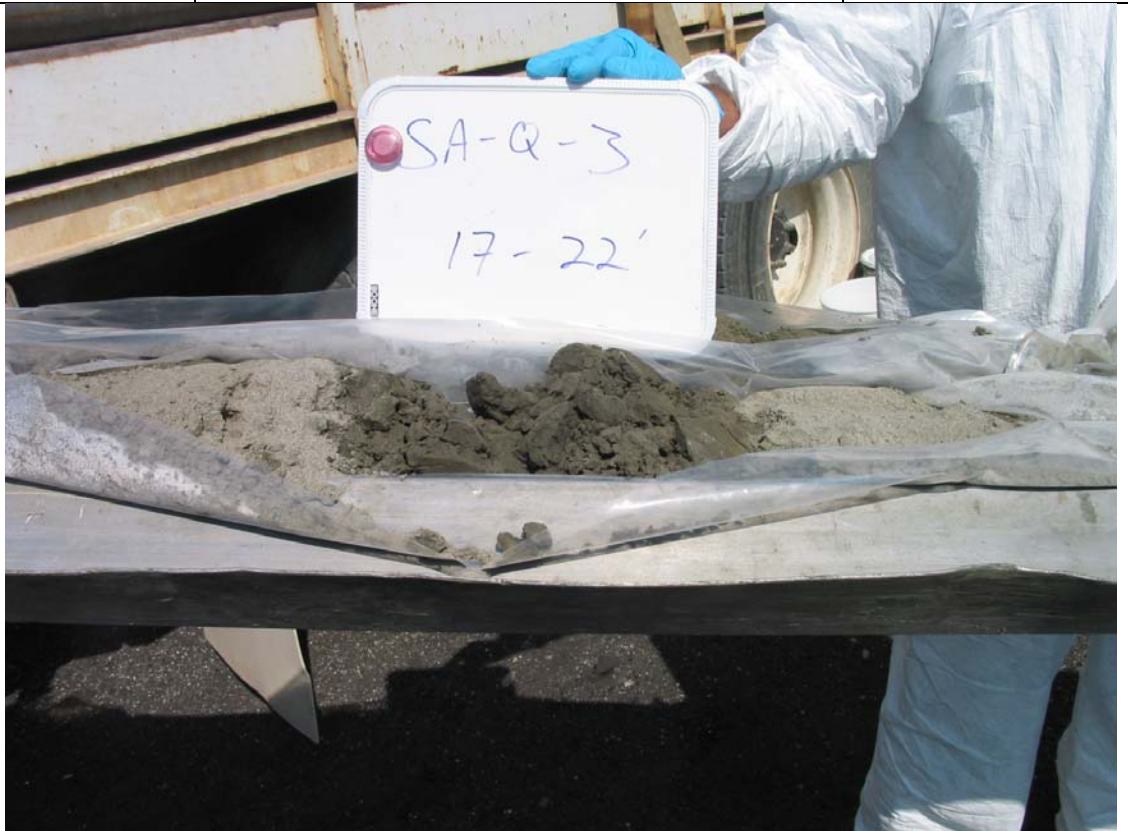
Client Name: Sauget Area 2 Sites Group		Site Location: Sauget, Illinois	Project No. 21561510
Photo No. 5	Date: 5/05/05

Description: SA-Q-3 (17-22')

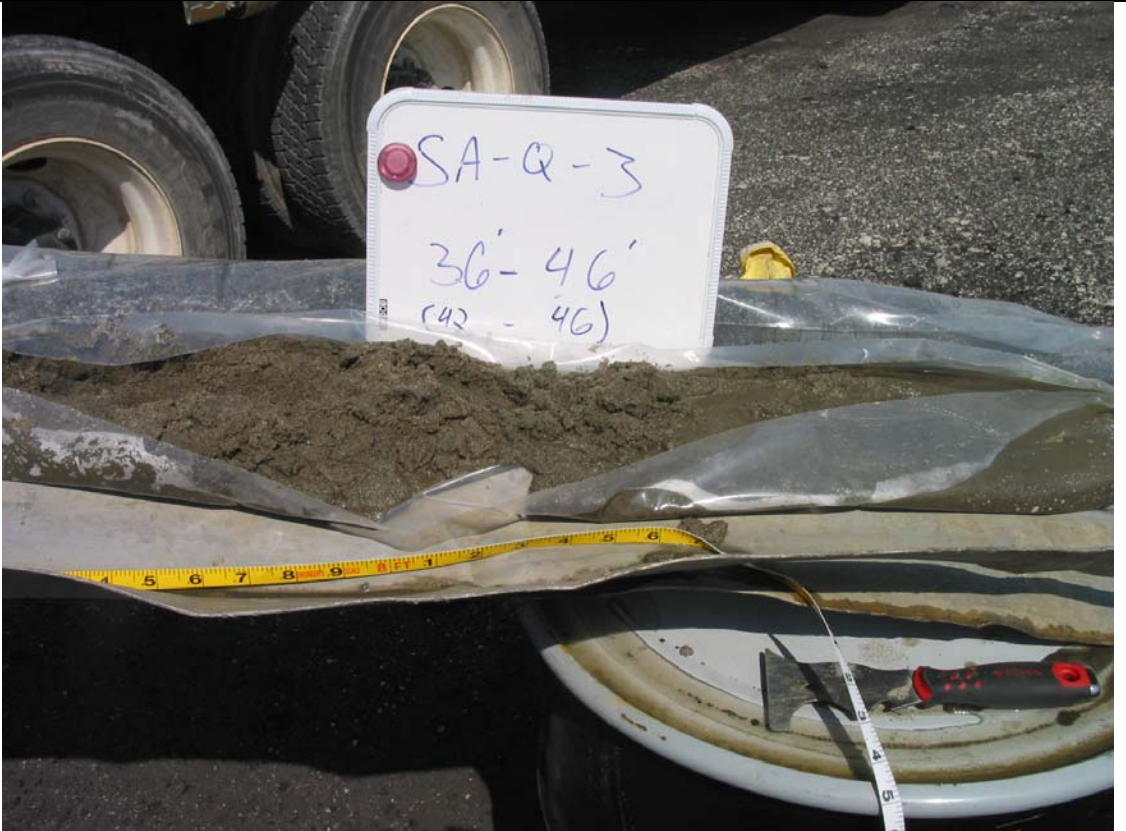
Client Name: Sauget Area 2 Sites Group		Site Location: Sauget, Illinois	Project No. 21561510
Photo No. 7	Date: 5/05/05

Description: SA-Q-3 (36-46')

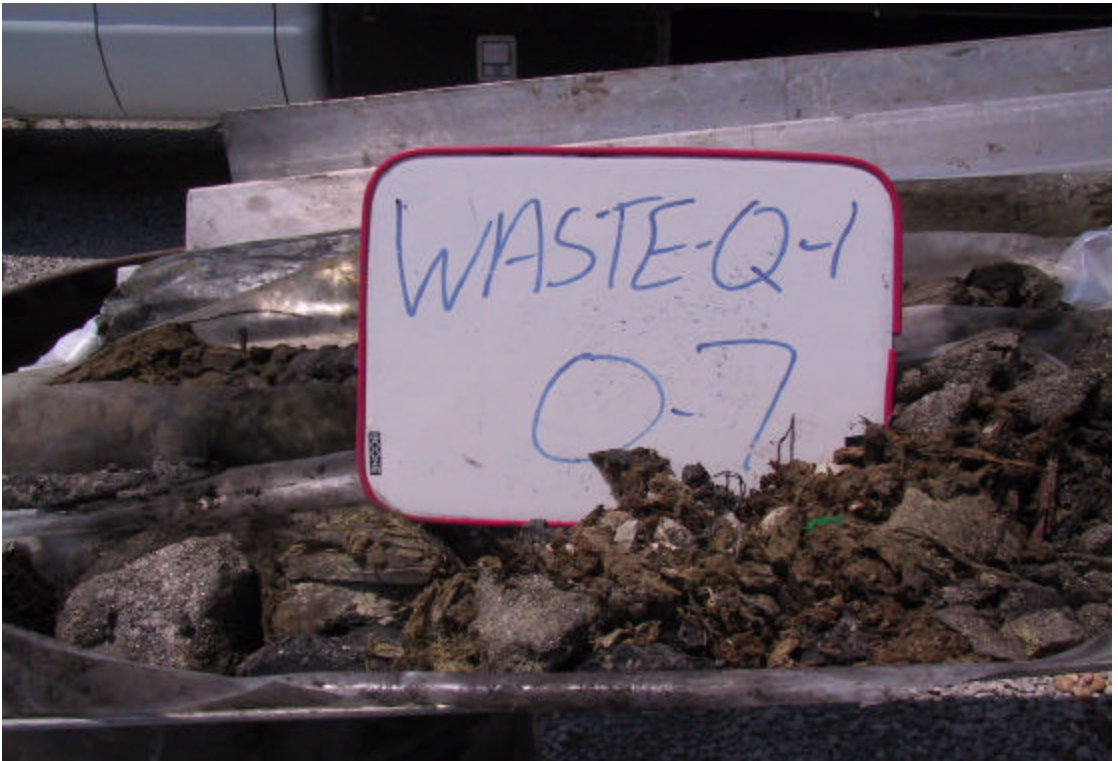
Client Name: Sauget Area 2 Group		Site Location: Sauget, Illinois	Project No. 21560888
Photo No. 1	Date: 7/26/02

Description: Waste-Q-1 (0-7')
